**Coastal Protection and Restoration
Authority of Louisiana (CPRA)**

**2015/2016 Annual Inspection
Report**

**COTE BLANCHE HYDROLOGIC
RESTORATION PROJECT
(TV-04)**

October 19, 2015
St. Mary Parish

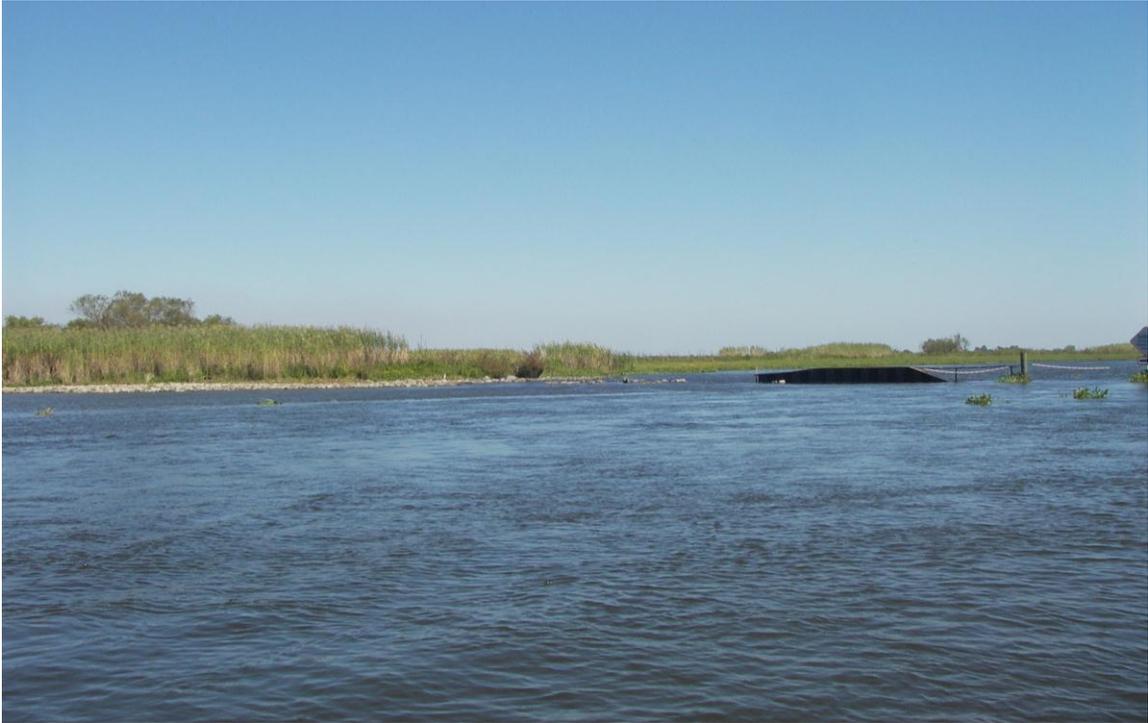
The Mud Bayou structure remains in fair shape. Rust on the sheet piles and the pile cap continues. The railings have been replaced with stainless steel cable and are holding up well. The north danger sign is missing and will not be replaced. Staff gauges are no longer functional. (Photos: Appendix B, Photo 1, 18)

Photo 1--Mud Bayou structure

Item	Condition	Physical Damage	Corrosion	Photo #	Observations and Remarks
Steel Bulkhead / Caps	good			1	Structure in good condition and functioning as intended. Rust continues to be monitored. Staff gauges need to be replaced.
Steel Grating	N/A				
Stop Logs	N/A				
Hardware	good				
Timber Piles	good				
Timber Wales	N/A				
Galv. Pile Caps	N/A				
Cables	Good			1	Railings have been replaced with stainless steel cables
Signage / Supports	good				The north danger sign is missing and will not be replaced.
Rip Rap (fill)	good				
Earthen Embankment	N/A

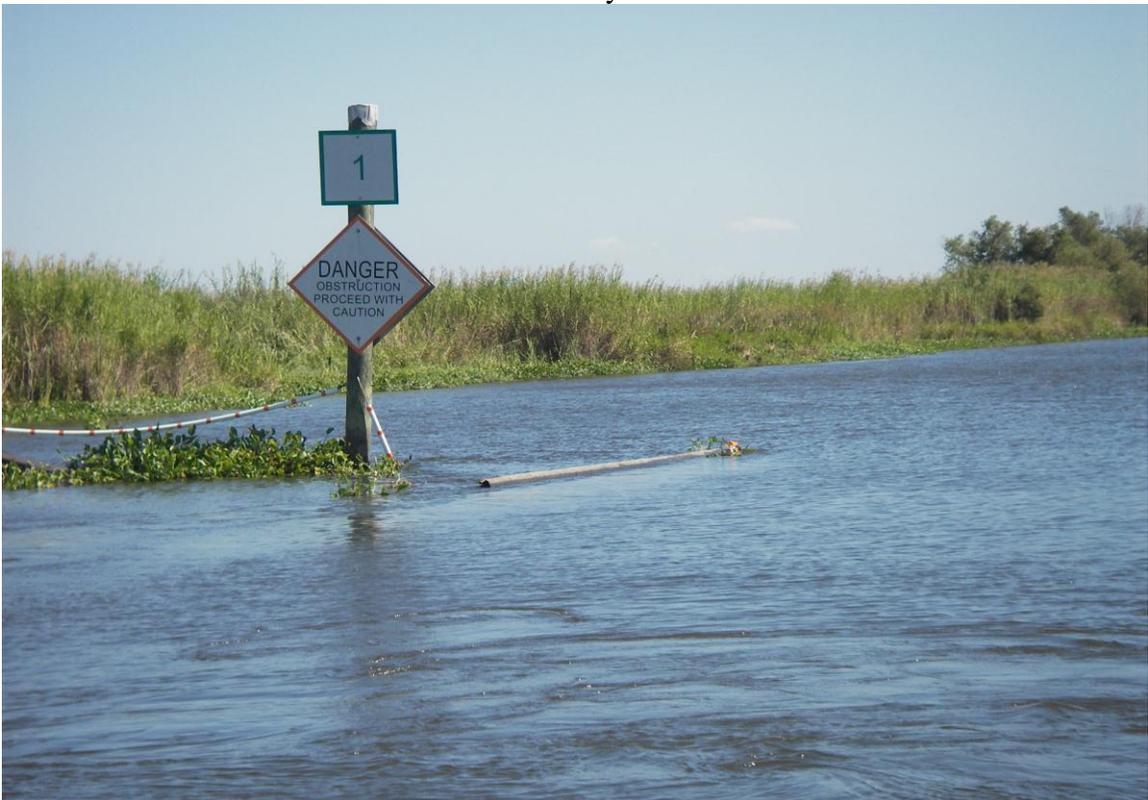
The piling and arrow sign replaced during the last maintenance event (north side) is missing, again. The piling and sign were still attached to the cable and floating on the interior side of the structure. Sheet piles and rocks on the end of the structure are stable and functioning as intended. Rust on the sheet piles will be monitored. The entire railing on this structure has been replaced with stainless steel cable and with the exception of the north piling mentioned above, is functioning as intended. The bayshore in front of this structure has eroded considerably over the years. (Photos: Appendix B, Photo 2, 18)

Photo 2—Broken pile and sign at Humble F Canal structure

Item	Condition	Physical Damage	Corrosion	Photo #	Observations and Remarks
Steel Bulkhead / Caps	good			2	Structure in good condition. Some slight rusting of pile caps.
Steel Grating	N/A				
Stop Logs	N/A				
Hardware	good				
Timber Piles	good				
Timber Wales	N/A				
Galv. Pile Caps	N/A				
Cables	Good			2	The railing has been replaced with stainless steel cable.
Signage / Supports	good			2	The piling and arrow sign replaced during last maintenance on north side is down and floating on the interior of the structure.
Rip Rap (fill)	good				
Earthen Embankment	N/A				The bay shore in front of the structure has eroded considerably since original construction.

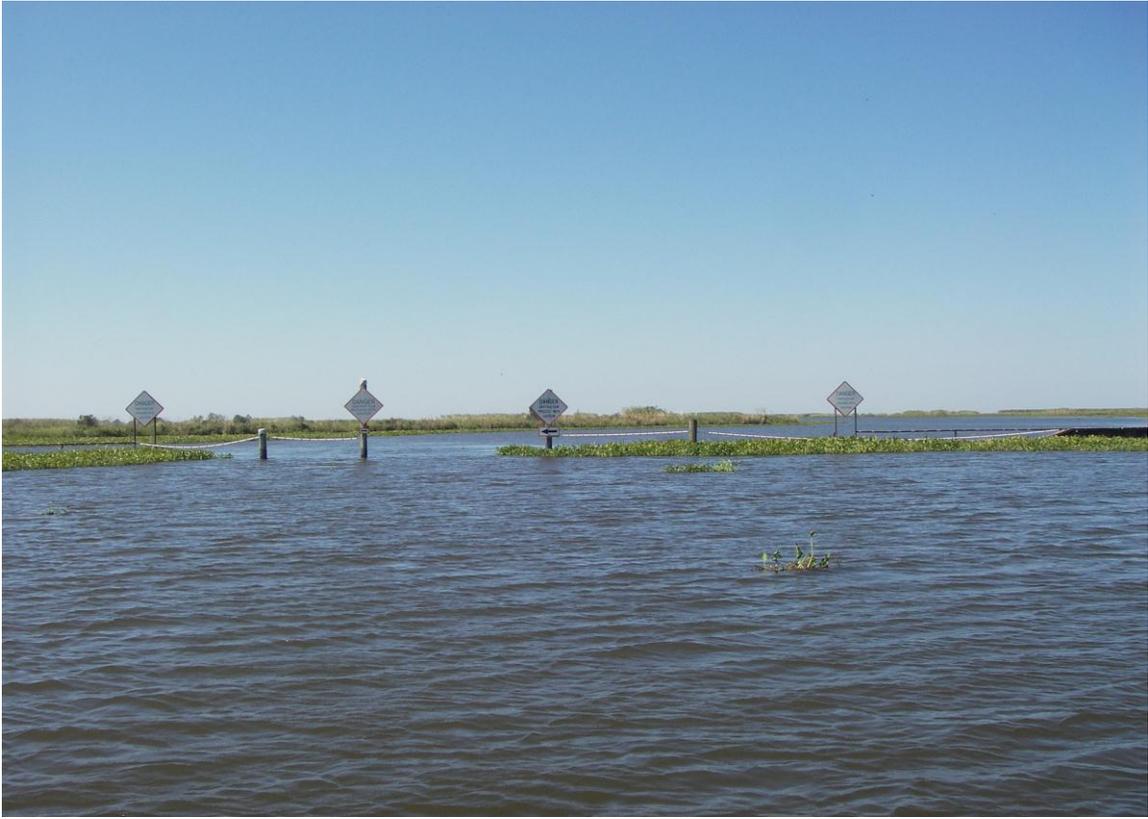
The structure is in very good shape after the recent maintenance. Rusting on the sheet piles will be monitored. (Photos: Appendix B, Photo 3, 18)

Photo 3—Bayou Long structure

Item	Condition	Physical Damage	Corrosion	Photo #	Observations and Remarks
Steel Bulkhead / Caps	good			18	Rusting on steel sheet piles will continue to be monitored.
Steel Grating	N/A				
Stop Logs	N/A				
Hardware	good				
Timber Piles	good				
Timber Wales	N/A				
Galv. Pile Caps	N/A				
Cables	Good			3	The railings on the structure have been replaced with stainless steel cables.
Signage / Supports	good			3	Signage is in place
Rip Rap (fill)	good				
Earthen Embankment	N/A

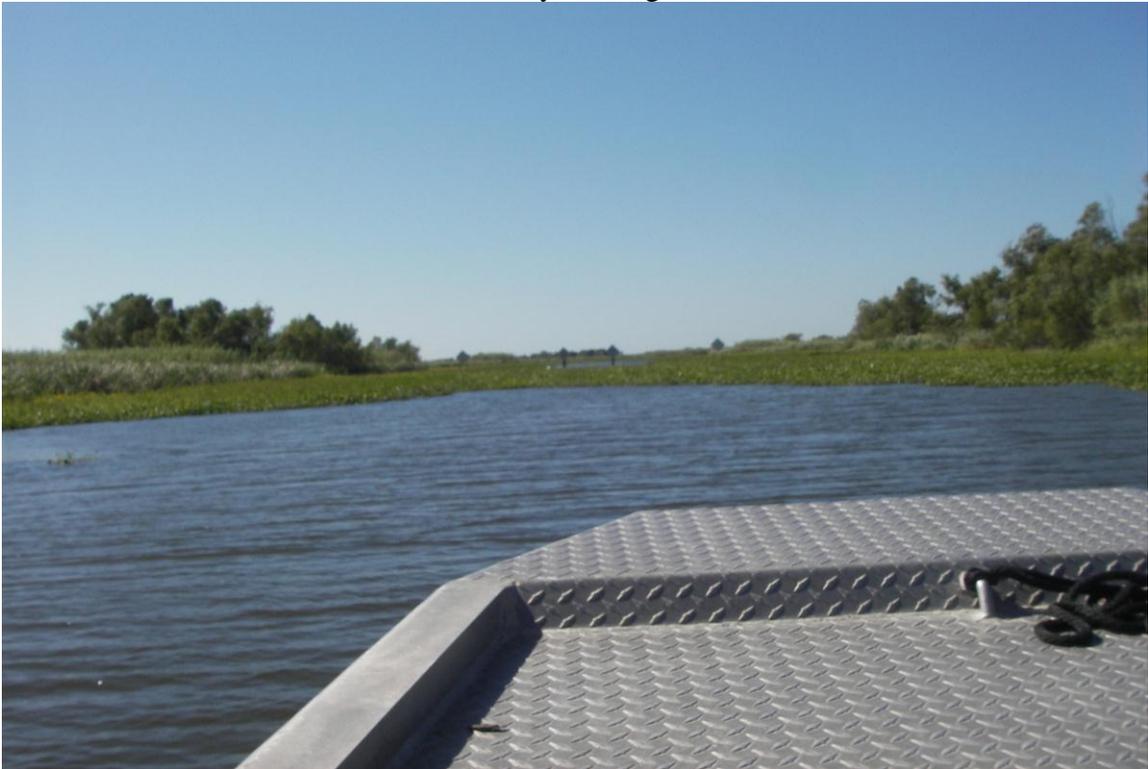
The structure is in very good post-maintenance condition. Rusting on the sheet piles will be monitored as the others. (Photos: Appendix B, Photo 4, 18)

Photo 4--Bayou Carlin Structure

Item	Condition	Physical Damage	Corrosion	Photo #	Observations and Remarks
Steel Bulkhead / Caps	good			4	Structure in pristine post-construction condition. Some slight rusting of pile caps. No immediate action necessary.
Steel Grating	N/A				
Stop Logs	N/A				
Hardware	good				
Timber Piles	good				
Timber Wales	N/A				
Galv. Pile Caps	N/A				
Cables	N/A				
Signage / Supports	good				
Rip Rap (fill)	N/A				
Earthen Embankment	N/A

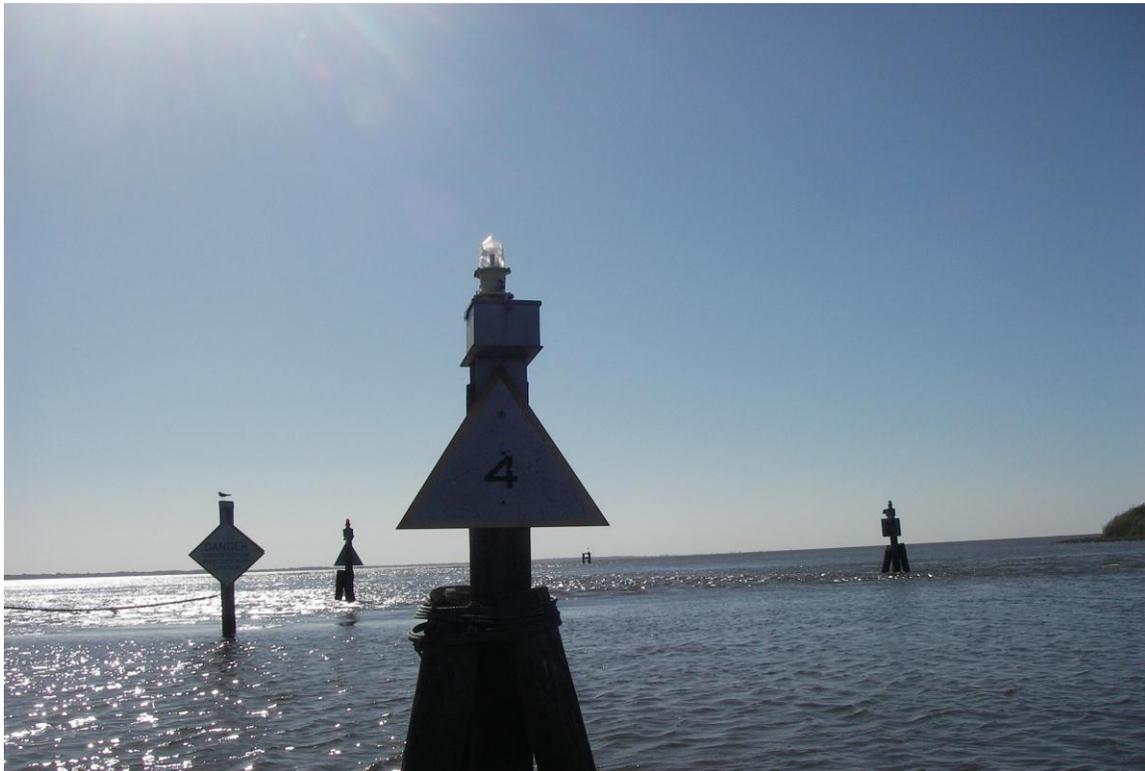
The cables installed to replace the rails continue to function as intended. Rock that was placed to extend the keyway closure has settled but is in otherwise good shape. Signage is all stable. Rust continues to worsen. (Photos: Appendix B, Photos 5-7, 18)

Photo 5--Humble Canal structure; east side

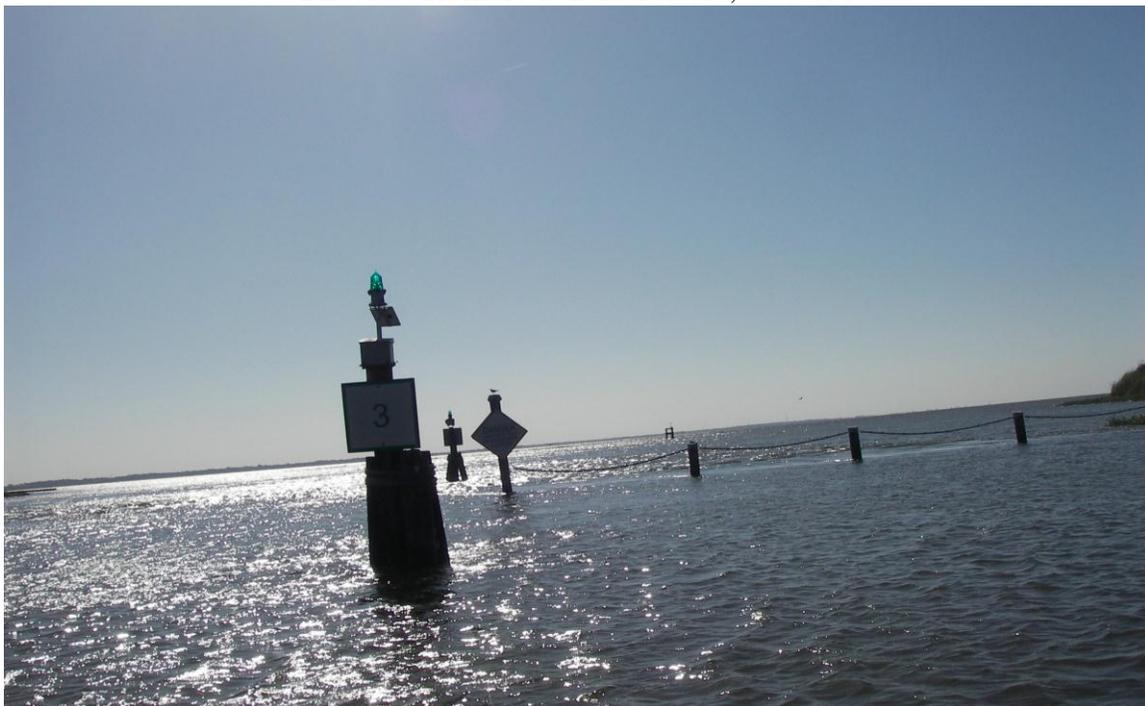
Photo 6—Humble Canal structure; west side

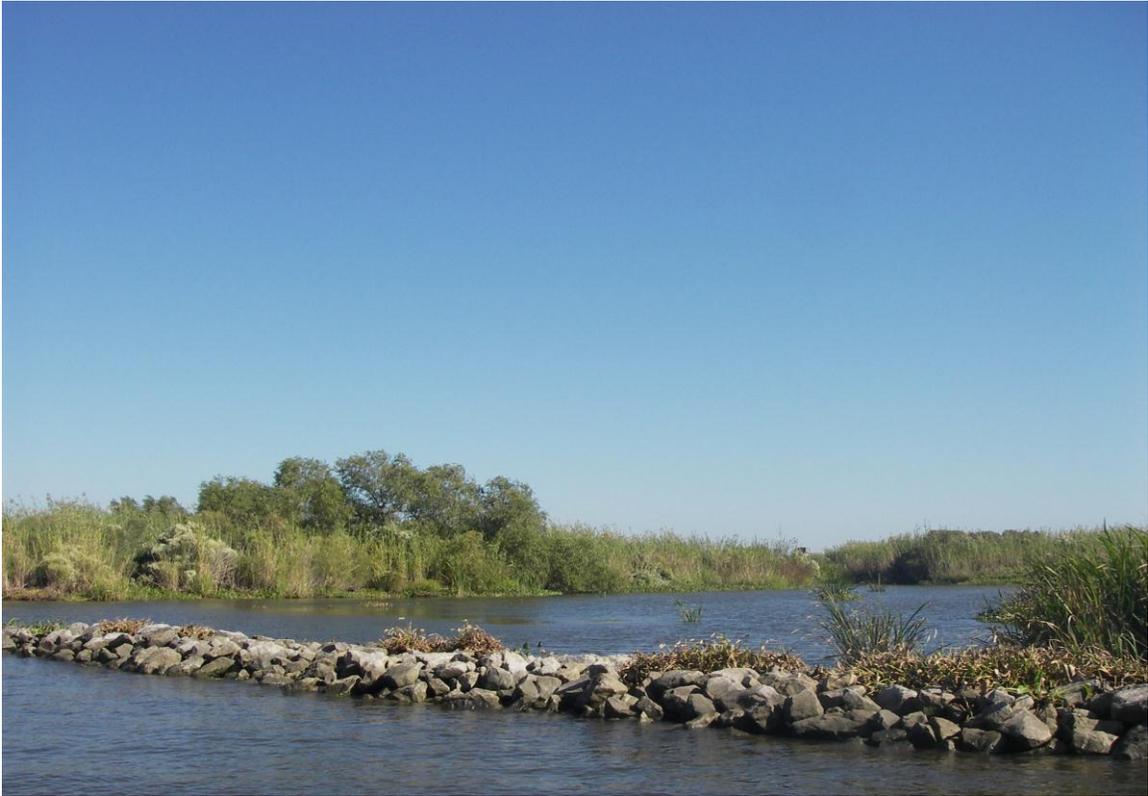
Photo 7--rock on east side of Humble Canal

Item	Condition	Physical Damage	Corrosion	Photo #	Observations and Remarks
Steel Bulkhead / Caps	good			18-Jan	Rusting on sheet pile will continue to be monitored. No immediate action needed.
Cables	Good			7-May	Railings have been replaced with stainless steel cables.
Stop Logs	N/A				
Hardware	fair				
Timber Piles	N/A				
Timber Wales	N/A				
Galv. Pile Caps	good				
USCG Lights	good			5	
Signage / Supports	good			6-May	
Rip Rap (fill)	good			7	Some settlement but still in good condition
Earthen Embankment	N/A

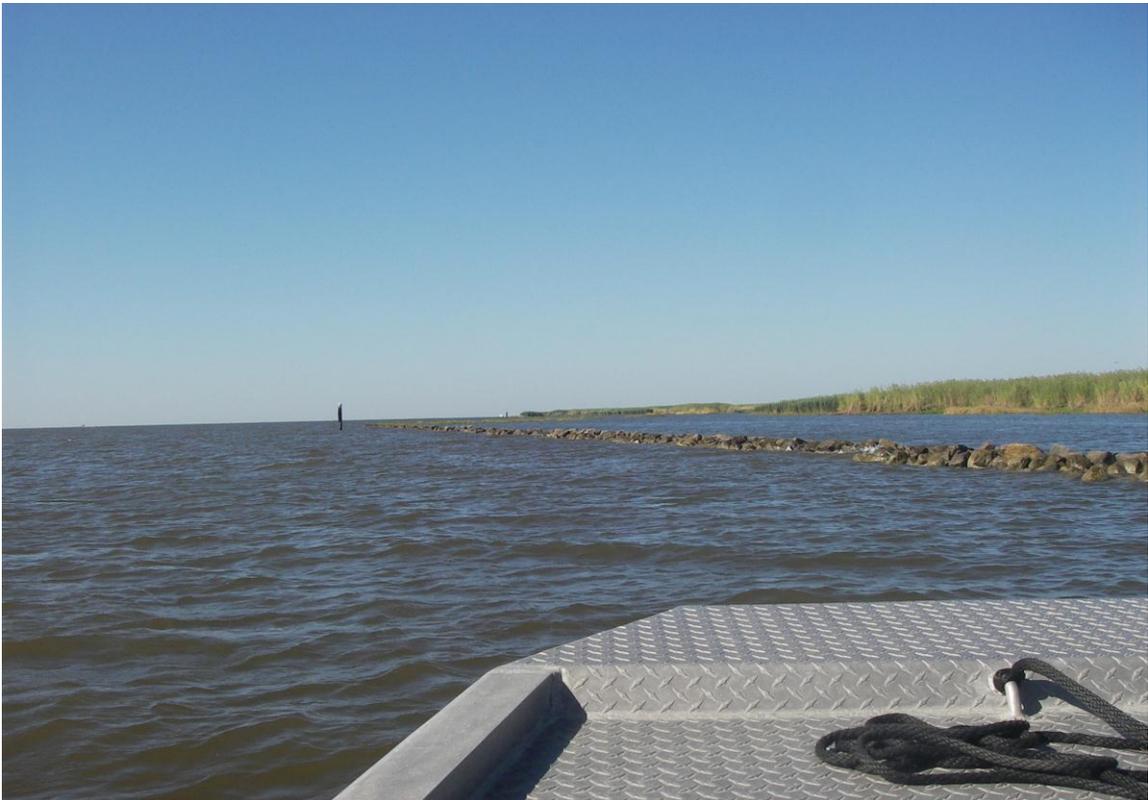
The settling of the dike has stabilized and is functioning as designed. Signage along the bay shore is intact. Rock at the intersections of School Bus Bayou and Humble Canal is in place and stable. Signage for the two weirs at the crossings is ok. (Photos: Appendix B, Photos 8-10)

Photo 8—typical section of School Bus Bayou dike

Item	Condition	Physical Damage	Corrosion	Photo #	Observations and Remarks
Steel Bulkhead / Caps	N/A				
Steel Grating	N/A				
Stop Logs	N/A				
Hardware	N/A				
Timber Piles	N/A				
Timber Wales	N/A				
Galv. Pile Caps	N/A				
Cables	N/A				
Signage / Supports	Good			8, 9, 10	Signage is intact
Rip Rap (fill) School Bus Bayou Low Level Weirs	Good Good			8 9,10	Settlement of rock dike has stabilized and is functioning as designed. Rip Rap at intersection of humble canal and school bus bayou is in place and stable.
Earthen Embankment	N/A

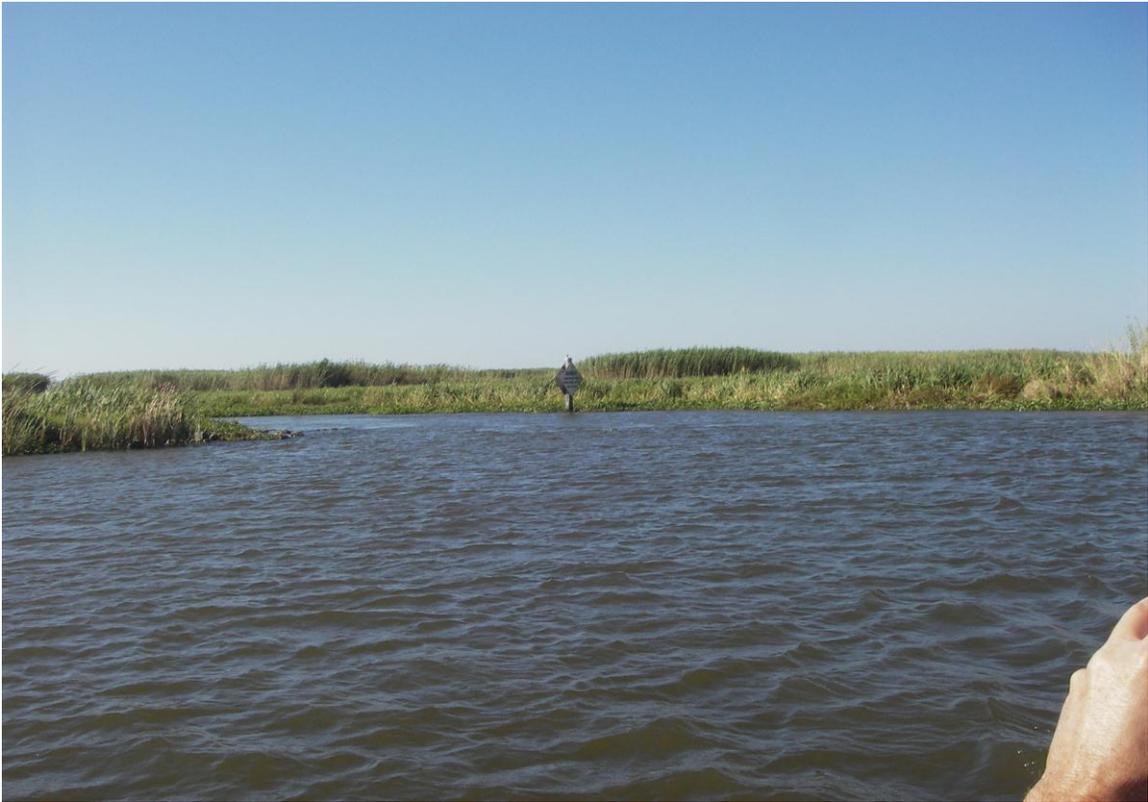
Photo 9—western weir at School Bus Bayou

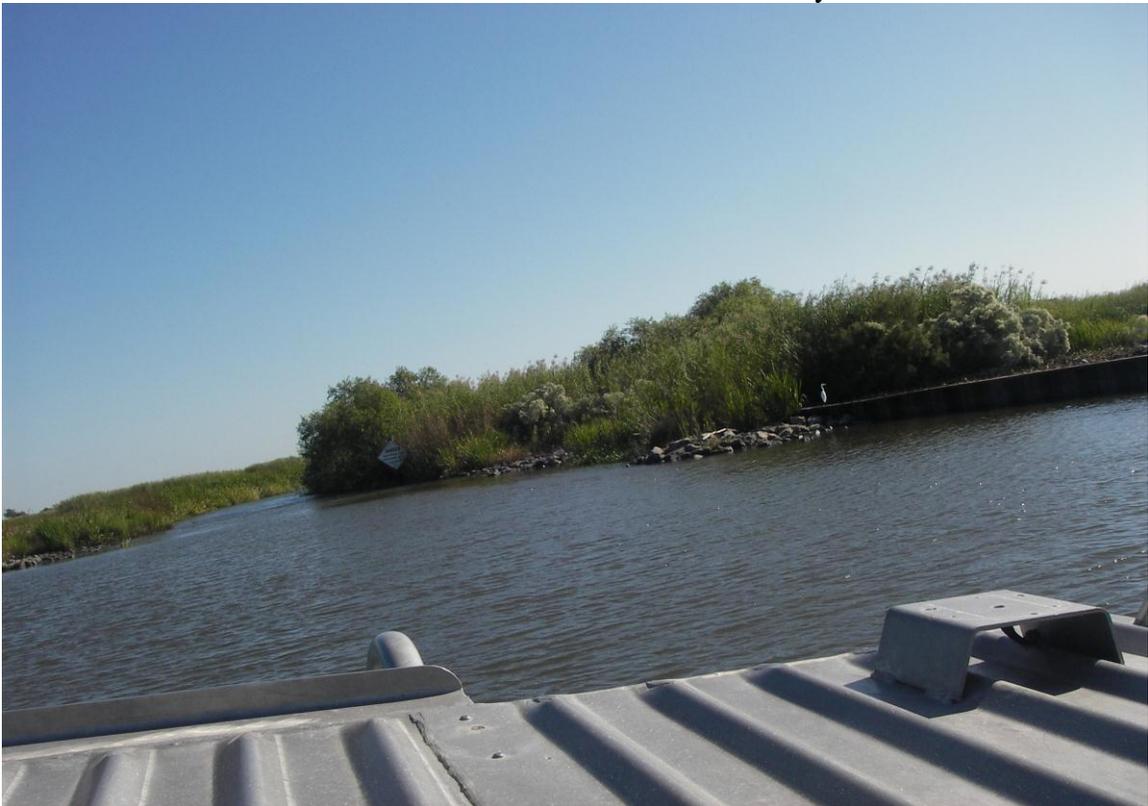
Photo 10—eastern weir at School Bus Bayou

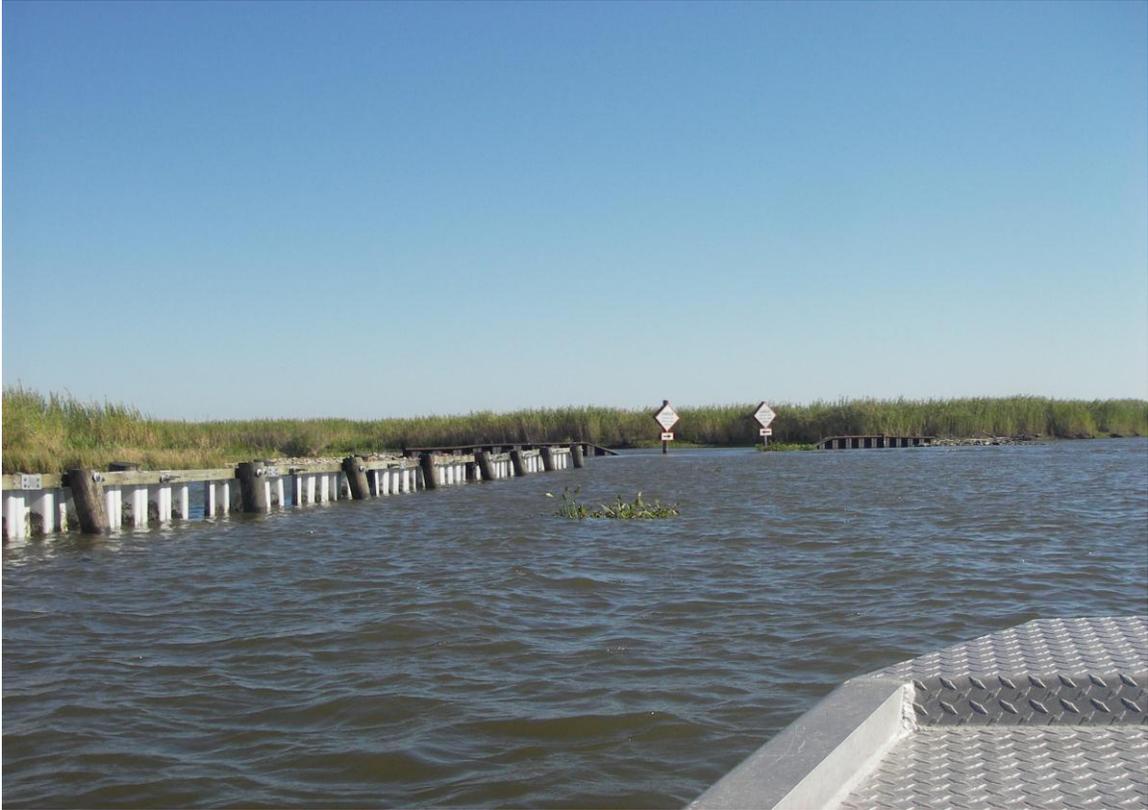
The gap between the eastern end of the structure and the shoreline has been somewhat closed with rock that was placed on the end of the PVC wall during original construction and salvaged. The coating on the sheet piles continues to rust as on the other structures and will be monitored. Signage is stable. (Photos: Appendix B, Photos 11-12, 18)

Photo 11—Jackson Bayou structure (and new PVC wall)

Item	Condition	Physical Damage	Corrosion	Photo #	Observations and Remarks
Steel Bulkhead / Caps	good			11, 18	Some slight rusting of pile caps.
Steel Grating	N/A				
Stop Logs	N/A				
Hardware	good				
Timber Piles	poor				
Timber Wales	N/A				
Galv. Pile Caps	N/A				
Cables	N/A				
Signage / Supports	good				
Rip Rap (fill)	good			12	The rock from original construction at the end of the PVC wall was salvaged and moved to the eastern end of the Jackson Bayou structure to fill a gap forming around the structure. The stone hasn't fully closed the gap but improved the situation slightly. Additional stone would be needed to completely shore up this gap.
Earthen Embankment	N/A

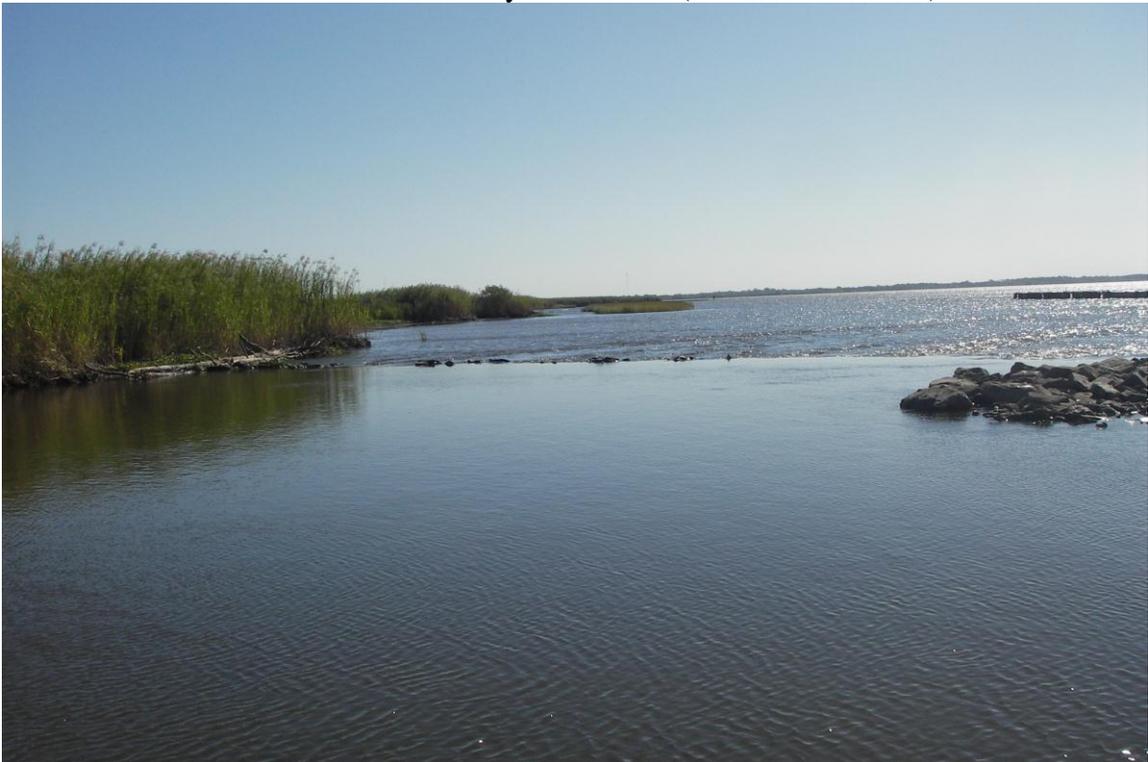
Photo 12—breach as repaired on eastern end of Jackson Bayou Structure

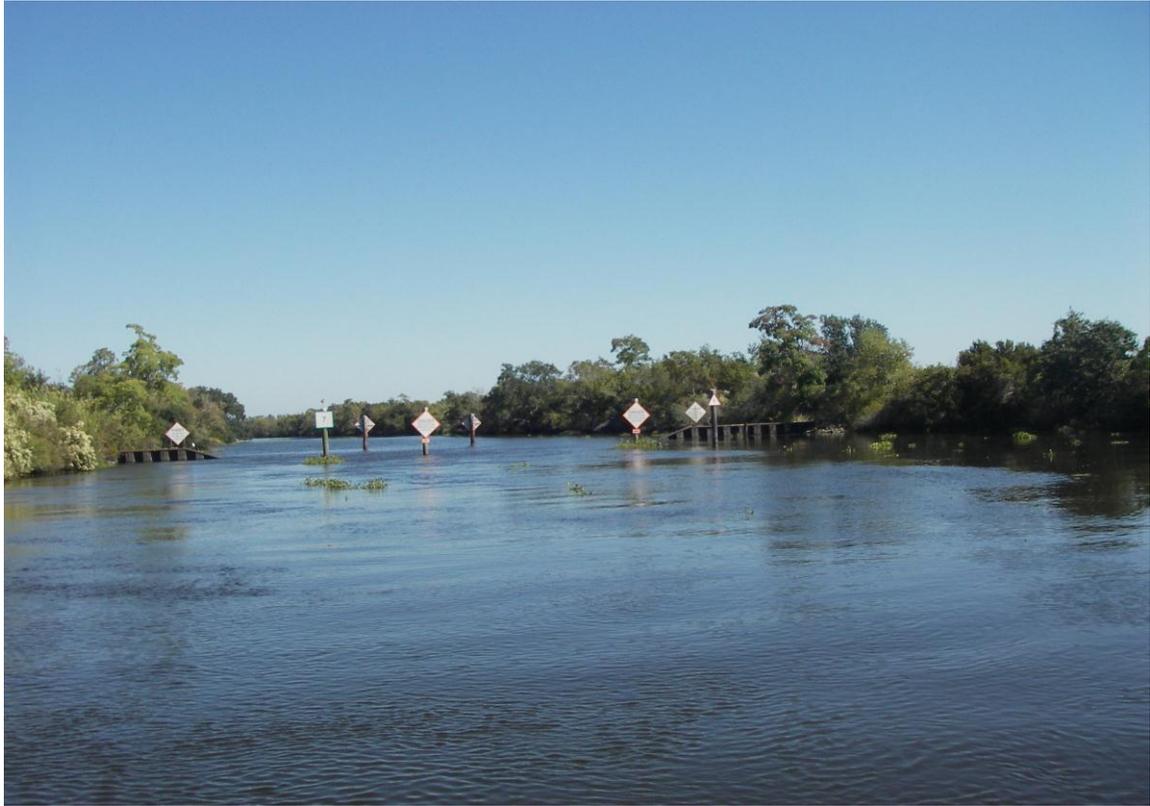
Rust on the sheet piles continues to worsen and will be monitored as well. Signage is in excellent shape. Rock along the shoreline between the structure and the PVC wall is also in excellent shape. (Photos: Appendix B, Photos 13-14, 18)

Photo 13—British American Canal Structure

Item	Condition	Physical Damage	Corrosion	Photo #	Observations and Remarks
Steel Bulkhead / Caps	good			13, 14, 18	Rust on Sheet piles continues to worsen. No action needed. Continue to monitor
Steel Grating	N/A				
Stop Logs	N/A				
Hardware	good				
Timber Piles	see signage				
Timber Wales	N/A				
Galv. Pile Caps	N/A				
Cables	N/A				
Signage / Supports	Good				
Rip Rap (fill)	good				
Earthen Embankment	N/A

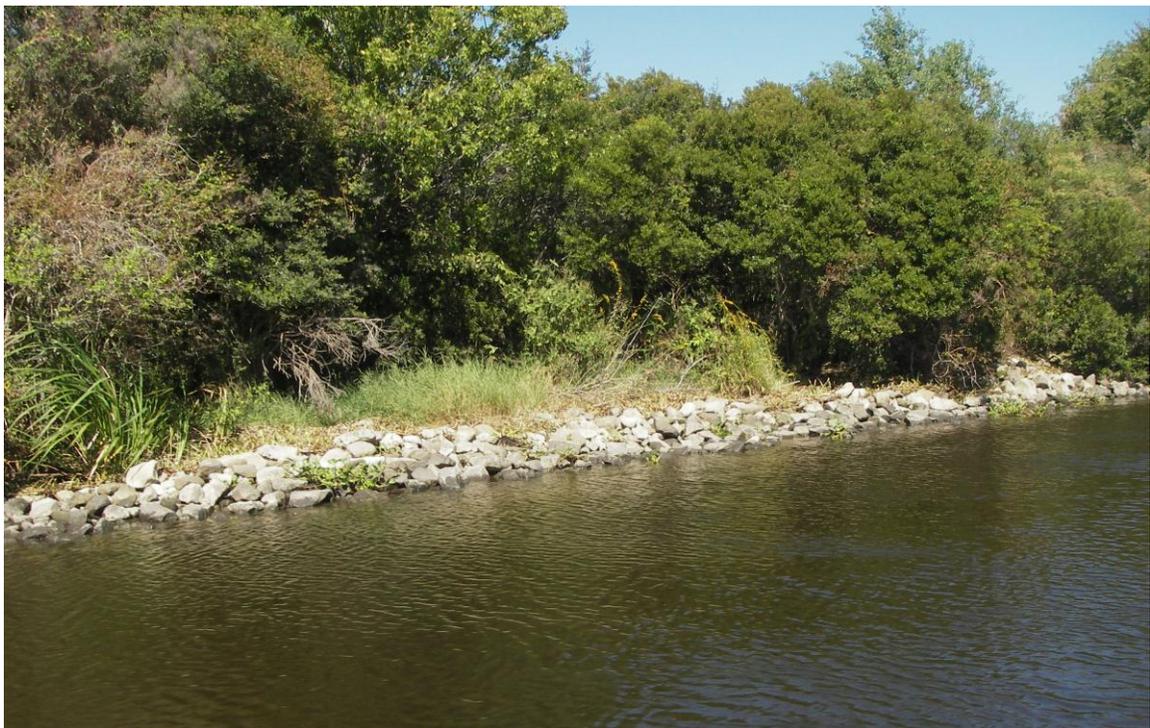
Photo 14—rock along British American Canal

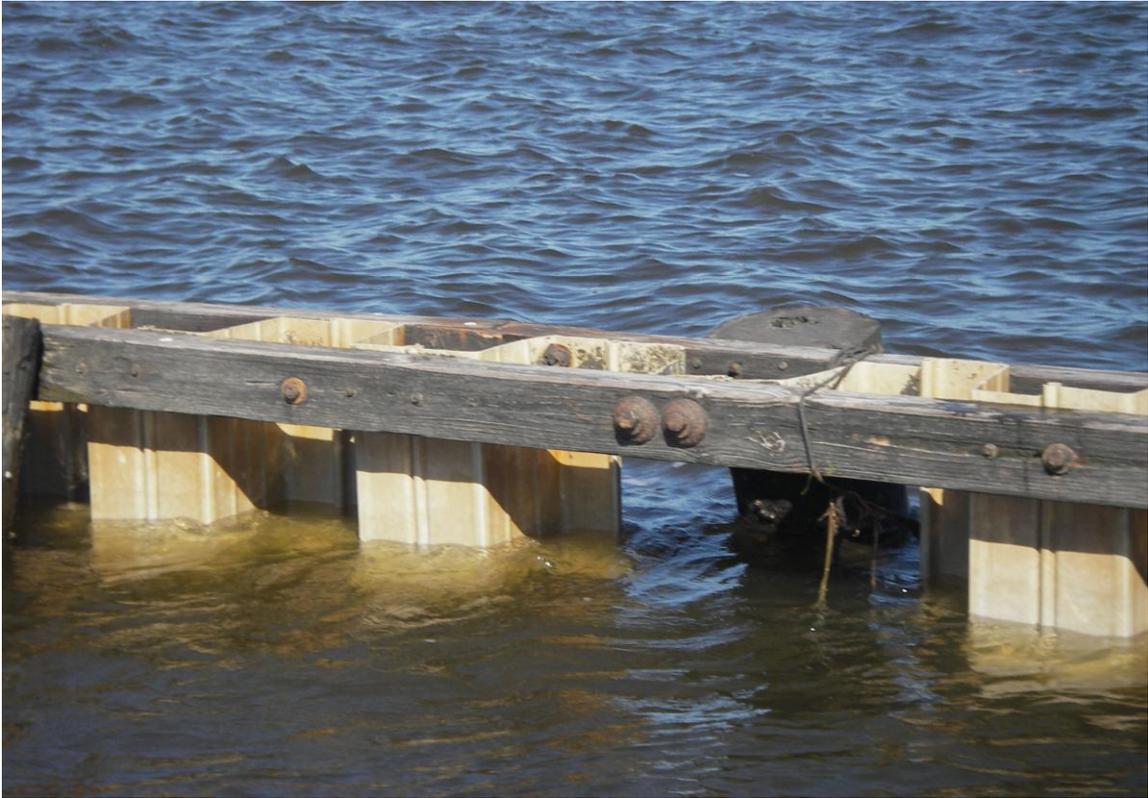
The PVC shoreline protection wall has begun to show signs of age. Several areas have either sheet pile or whalers missing or deteriorated. Hardware is rusting significantly. Some of the timber piles are also showing signs of decay. The wall, for the most part, is still functioning as intended, however repairs will soon become necessary. Signs are all in place and stable. The two new wall sections that were installed during the 2015 maintenance event are in good shape. Scour at the base, that was noticed during the final inspection is still evident but stable. However, rock should be placed at the base of this new wall. (Photos: Appendix B, Photo 15-17)

Photo 15—Typical section of PVC wall

Item	Condition	Physical Damage	Corrosion	Photo #	Observations and Remarks
PVC Sheet Pile				15,16, 17	The old PVC wall is deteriorating, missing sheet pile or whalers
Old Wall	Fair				No gaps are wider than 3-4 feet however and the wall is still functioning
New Wall	Good			11	New PVC Wall - good condition, scour at base remains stable. Recommend rock at base in future.
Steel Grating					
Stop Logs					
Hardware	Fair			16-17	Old PVC wall - rusting hardware, missing whalers
Timber Piles	good				Nearly all pile caps missing. Attempts to replace these have been unsuccessful. Condition of the piles will be monitored.
Timber Wales	Fair				Old PVC wall - some missing
Galv. Pile Caps					Pile caps are missing. Past attempts to replace them haven't been effective.
Cables					
Signage /Supports	good				All signs are in place. Some retaping with reflective tape is required.
Rip Rap (fill)	good				Old PVC Wall - Rock placed along the inside and outside of the PVC wall is still in place and functional. No action necessary. New PVC Wall - recommend adding rock to base to protect from additional scour.

After the last maintenance event, the components of the Cote Blanche Hydrologic Restoration Project are in basically fair condition and functioning as intended. However, the original PVC wall has begun to show signs of fairly serious deterioration. The new PVC wall has scour at the base and could potentially become a problem. Rust on several of the structures continues to worsen. Stainless steel cable attached to driven timber piles continue to perform better than the rails that were installed on the original structures. This method should be considered during construction of similar structures in harsh environments such as this in the future.

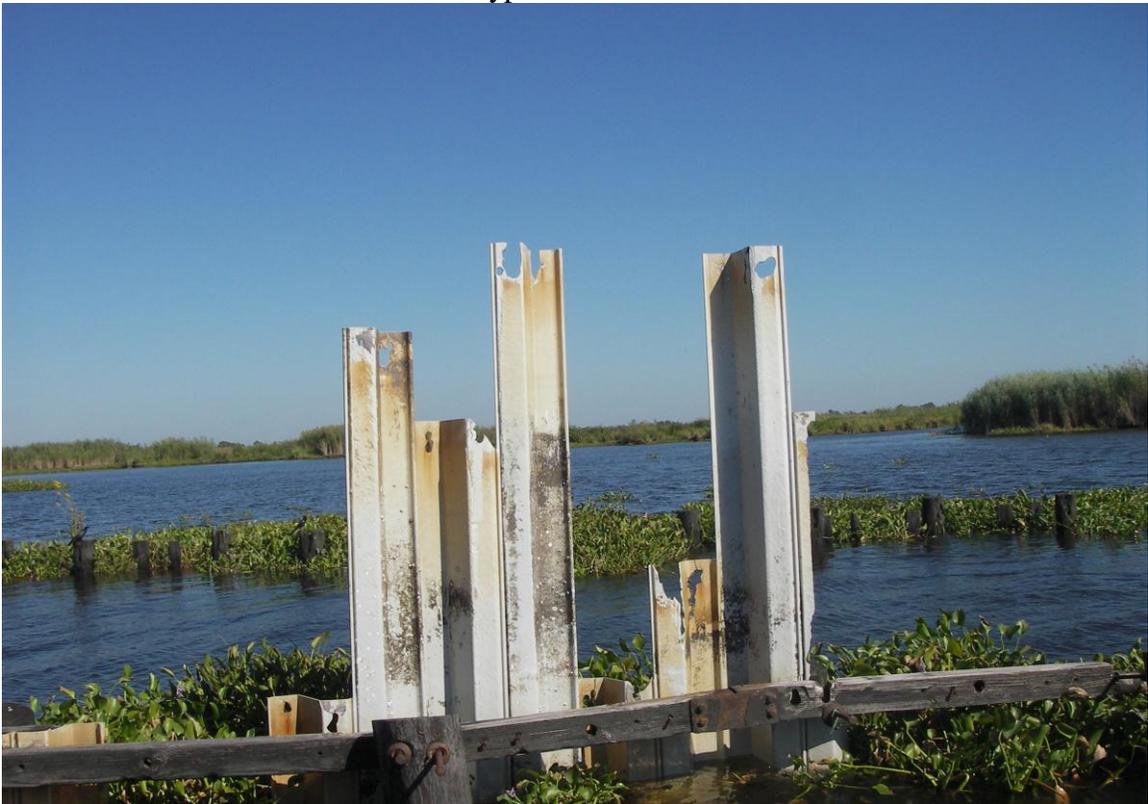
Photo 16—rising sheet pile on PVC wall

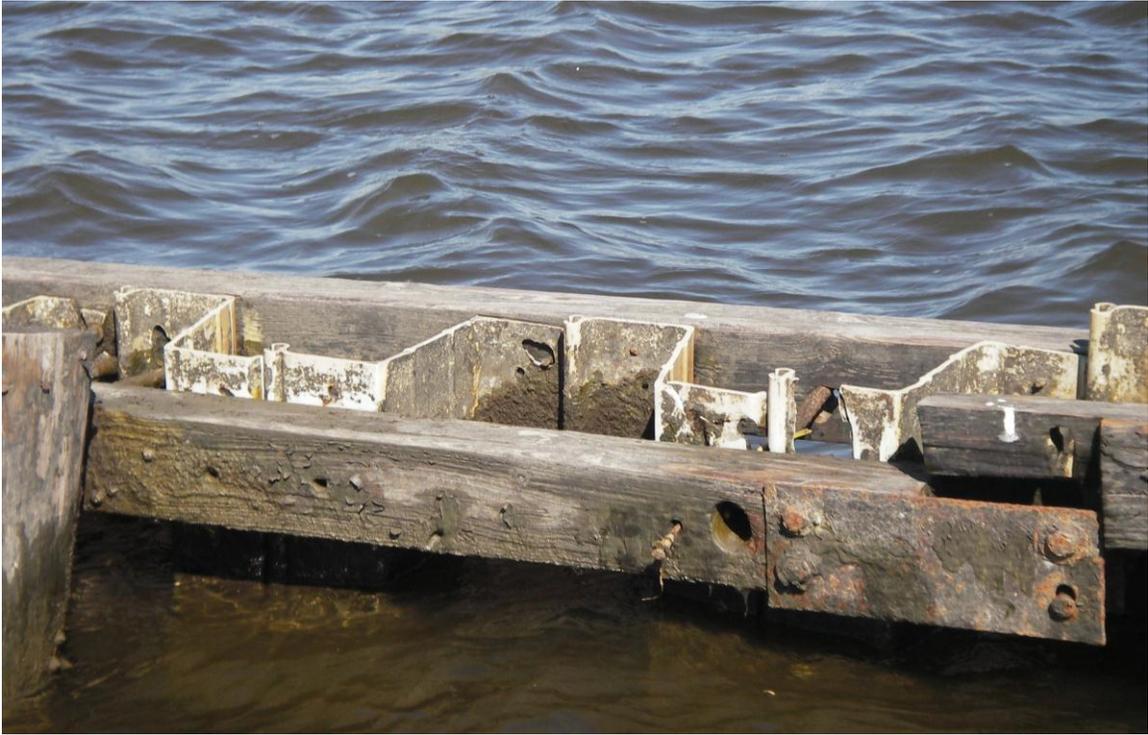
Photo 17—rusted/broken hardware on old PVC wall

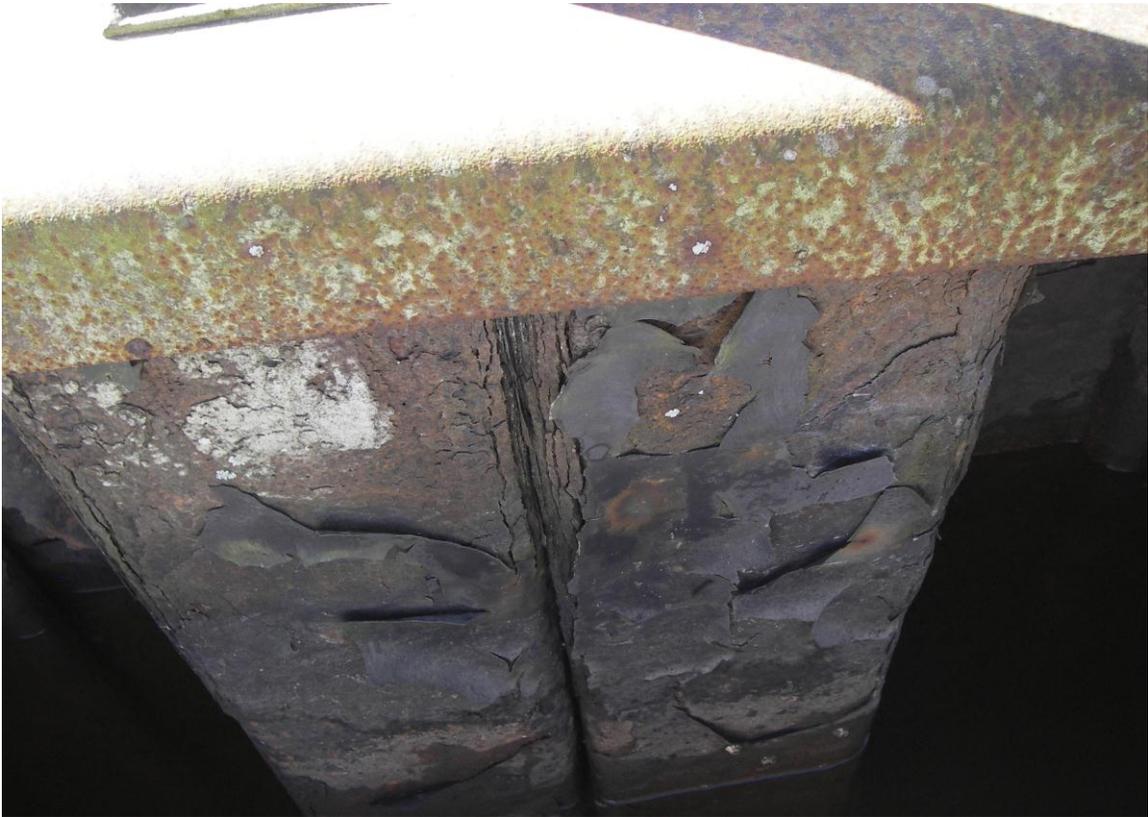
Photo 18—typical rust on Fixed Crested Weir Sheet Pile
